Eclipse SAN Routers

Enterprise/ Operating System internetworking
(E/OSi) Version 04.07.00
SANvergence Manager 04.07.00

Release Notes P/N 958-000364-470

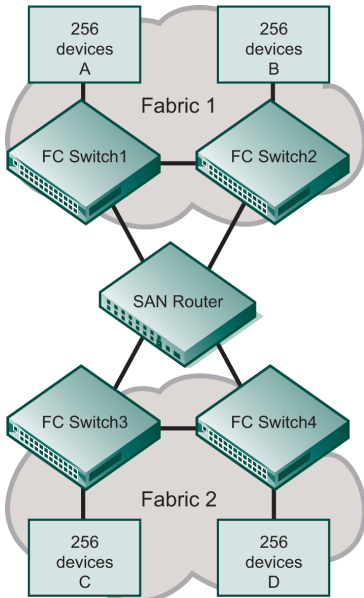
Note	Category
<p>Consider the performance of each Fibre Channel switch in a fabric when zoning devices external to the fabric. As a “conservative” starting point, we recommend configuring a maximum of 1024 <i>interfabric sessions</i> on an switch. An <i>interfabric session</i> is a device external to a fabric that is included in a zone with a device internal to a fabric on a specific Fibre Channel switch.</p> <p>For a Fibre Channel switch in a fabric, the number of configured sessions can be summarized as $X * Y \leq 1024$ where:</p> <ul style="list-style-type: none"> X = number of devices external to this fabric zoned with Y Y = number of devices internal to this fabric and attached to this switch zoned with X

<p>Valid Zone Configuration</p> <ul style="list-style-type: none"> Zone1 = 1-10 A devices, 1-20 C devices ($10 * 20 = 200$ sessions) Zone2 = 1-10 A devices, 1-20 D devices ($10 * 20 = 200$ sessions) Zone3 = 11-20 A devices, 21-80 C devices ($10 * 60 = 600$ sessions) Zone4 = 1-40 B devices, 21-30 D devices ($40 * 10 = 400$ sessions) <p>Interfabric Session Totals</p> <ul style="list-style-type: none"> FC switch1 = 1000 (200 + 200 + 800) FC switch2 = 400 (400) FC switch3 = 800 (200 + 600) FC switch4 = 600 (200 + 400) 	R_Port
